## REPAIR OF ANCIENT BUILDINGS

## A. R. POWYS

Secretary of the Society for the Protection of Ancient Buildings

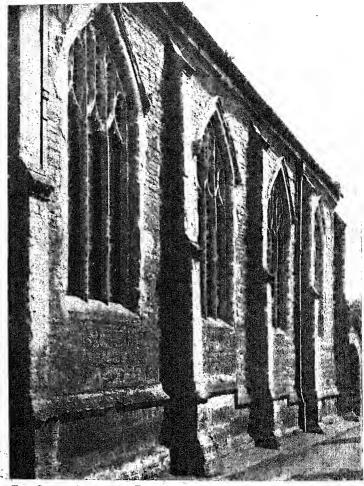
THE SOUTH AISLE AND TRACERIED WINDOWS OF HENLEY-IN-ARDEN CHURCH, WARWICKSHIRE, REPAIRED BY THE TILE METHOD IN 1922

The effect of weathering should be noted. The photograph was taken in 1928. When finished, the work was as bright as the finished window of Limpsfield.

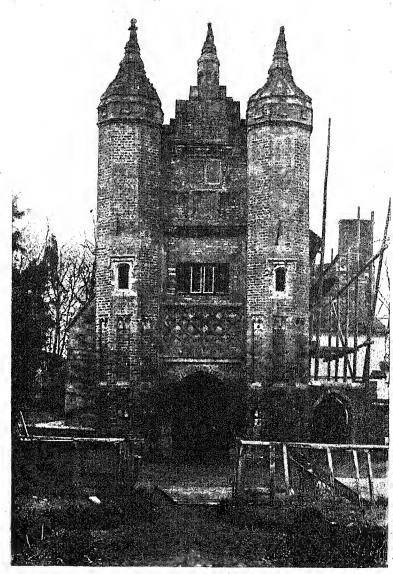
Fig. 5. West Stow Hall, Suffolk, After Repair, 1906

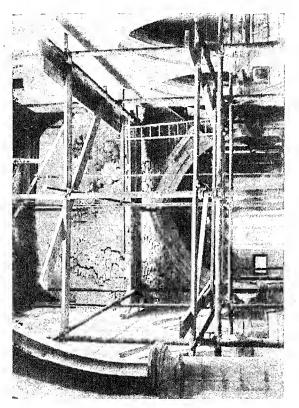
Fig. 6. Hanborough Church, Onon, Chancel Arch During Repair

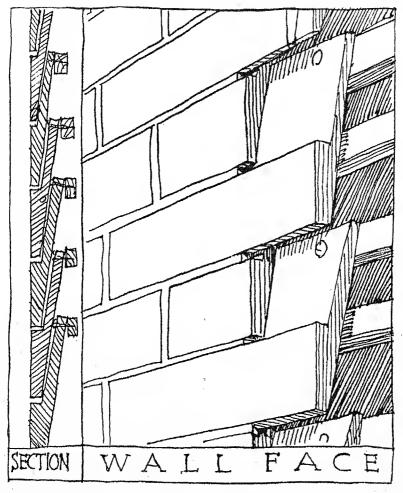
Fig. 7

accompanying sketch (see Fig. 7) will illustrate the form of tiling. It is usually found in conjunction with a "brick-nogged" wall, and the tiling nails are driven into the brick joints and into the upright timbers. On a vertical wall this tiling forms an excellent protection from the weather, and being properly bedded in mortar and without exposed edges, it cannot be damaged by a ladder carelessly leant against the wall face.

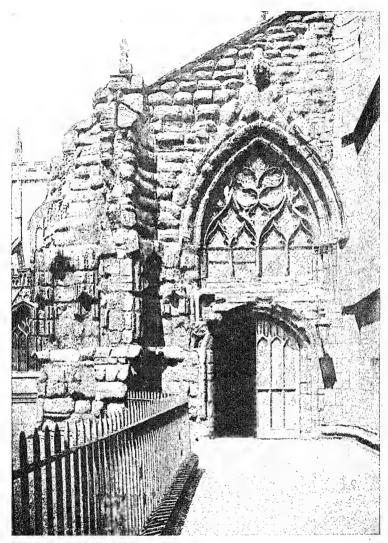
Fig. 17. Chester Cathedral. Surface Decay Due to Neglect, but still Reparable, 1914

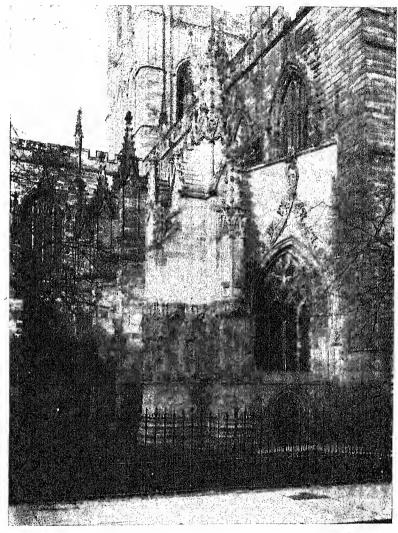
Fig. 18. Chester Cathedral. Surface Renewal Instead of Surface Repair

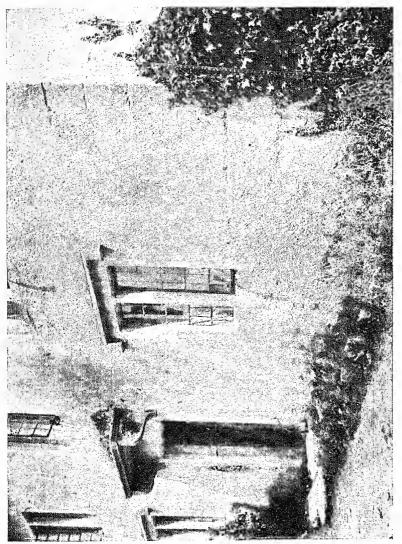
Fig. 19. A Good Rough-cast Surface and the Quoin of a Rubble-built Wall from a Cottage at Castle Combe

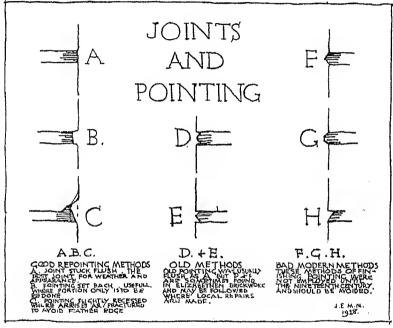
FIG. 20

joint has been pressed back from the surface in a plane parallel to it, sometimes made to project, commonly having an inverted V section, or it has been cut back at the top and at the bottom (see D and E, Fig. 20). None of these fanciful finishes are to be recommended on old walls. Putney Church Tower, Fig. 21, was pointed in this disagreeable way. The sanest finish for a joint is flush, or as nearly flush as is possible without spreading thin films of mortar over the irregularities in the stones. A photograph of repairs at Ratcliffe-on-Soar shows a finish that is satisfactory (see Fig. 16.)

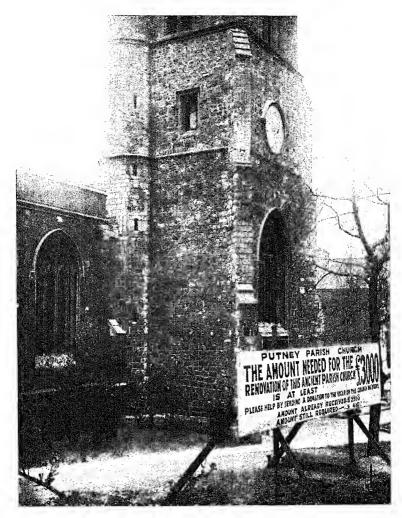
The custom of darkening mortar to make it "in keeping" with adjoining weathered work is contrary to medieval practice, and, therefore, in reality is altogether "out of keeping" with buildings of that tradition. Further, where this is done, though it may give a colour more like that of the old work immediately on completion, in a few years it will be seen to have robbed an old building of its lively brilliancy, for such darkened mortar can never give the variety of light and dark which is part of the characteristic beauty of an old building.

Fig. 21. The Tower of Putney Church After Pointing with Black Cement with Raised Ribbon Joints

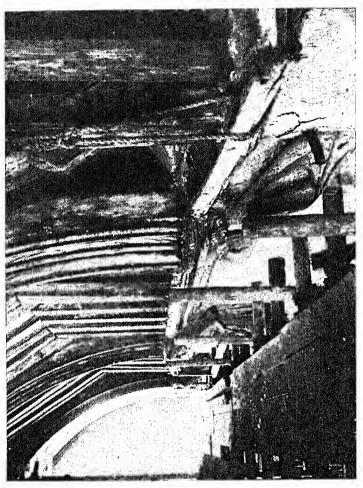
PENSHURST PLACE. ROOF OF BARON'S HALL DURING REPAIR BY MR. WM. WEIR 22.

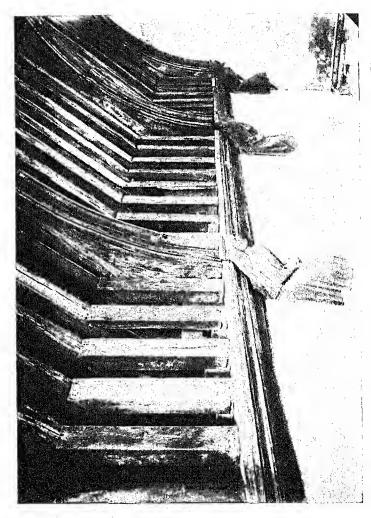
Penshurst Place. Roof of Baron's Hall After Repair by Mr. Wm. Weir Fig. 23.

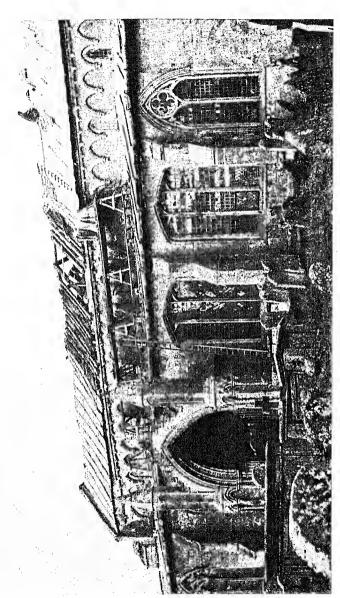
West Walton Church from the South During Repair, 1907 FIG. 27.

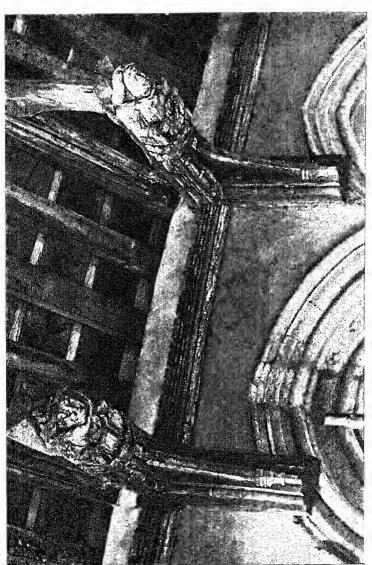
FIG. 28. West Walton Church. The Nave Roof After Repair, 1907

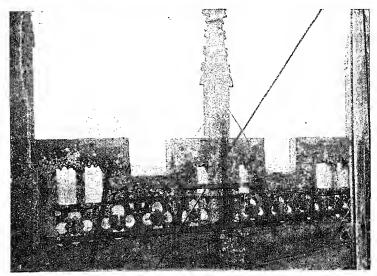
A flagpole stayed from a turret or from the battlements of a church tower will loosen and damage the masonry to which it is attached. When this arrangement exists it should be altered and better fixing provided from well within the tower. In the photographs of Kingston Church tower, Somerset

(Figs. 29, 30, and 31), it will be seen that the flagpole was fixed in the way condemned here and that it is now refixed as it should be. Apart from the damage done by a flagpole when stayed from battlements, it cannot be conveniently lowered, and such an arrangement makes it difficult and awkward to repaint or to repair a broken flag cord.

Fig. 30. Parapet Split by Ironwork

The method which has been found satisfactory in all respects is to fix the flagpole to a central stay-post with metal holdfasts which can be detached by the removal of a nut near the top of the stay-post and another just above the roof. When a pole is so arranged it is easy to lower it for repairs or painting. It is the provision and fixing of the stay-post which requires special care and attention. This post should be about six inches square of English oak. It should stand at least six feet above the roof and should descend at least six feet below the roof beams. The weight of the post may be taken at its very foot by a special stout oak beam spanning right across the tower from wall to wall, or it may be taken by the central roof beam. If the weight is taken at the roof-level the bottom end of the stay-post may be held upright by iron tie-rods anchored in the four walls of the tower, or by diagonal bracing-struts springing from the foot of the stay-post to the roof timbers. In a church tower a beam at this level at the foot of the stay-post is, however, often useful to take tackle for raising and lowering the bells. The junction of such a stay-post with the roof covering is often a point where slight leaks occur. It is usual to turn the lead sheets with which the roof is covered three inches or so up it and to close nail a lead flashing above this on to the stay-post. A more permanent way to secure this joint is to cover the stay-post with lead or copper, and in this case the metal holdfasts are fixed after the lead or copper is put on. Precautions, however, must be taken to shield a lead covering from the action of the tannic acid in oak.

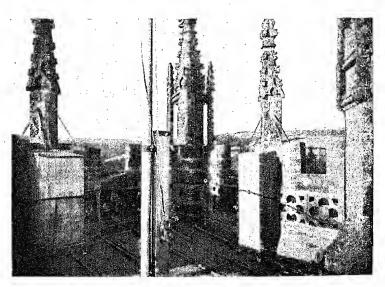
Fig. 31. Parapet After Repair, Ironwork Removed and Gunmetal Substituted

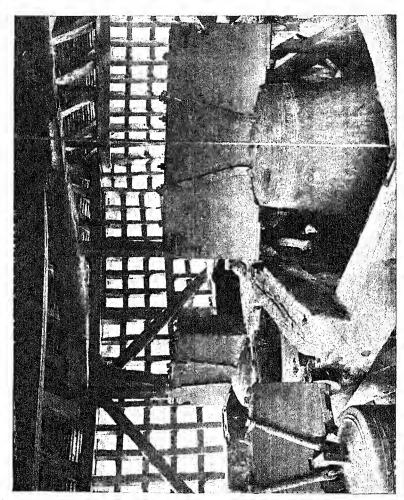
Fig. 36. The Interior of the Belfry at East Bergholt

In the explanation of the photograph (Fig. 36) of the interior of the belfry at East Bergholt, it may easily be seen that the bells are not hung for ringing, for there are no bell wheels. The canons have been cut from two of the bells that are seen in the photograph and these are supported from the headstock by bolts through the crowns of the bells. One bell on the extreme left of the picture—a modern bell—has a low angular canon which is a little "tucked up" into the headstock. The cage is an old one framed of oak in an unusual manner, one pit being set diagonally. The belfry, too, is unusual, not only because of the pretty grillage of oak which encloses it, but also because after the tower fell it was set on the ground under a low independent roof. When the photograph was taken the cage and belfry were in need of attention and repair.

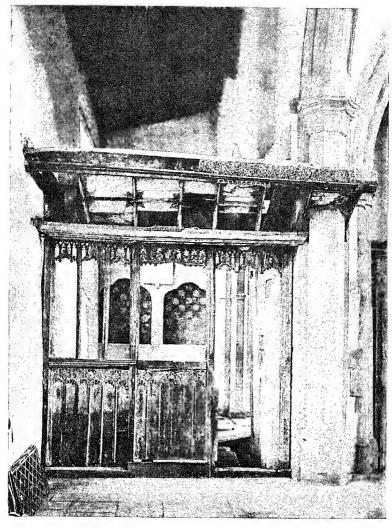
Fig. 37. Hanborough Church, Oxon. The Screen Before Repair in 1910

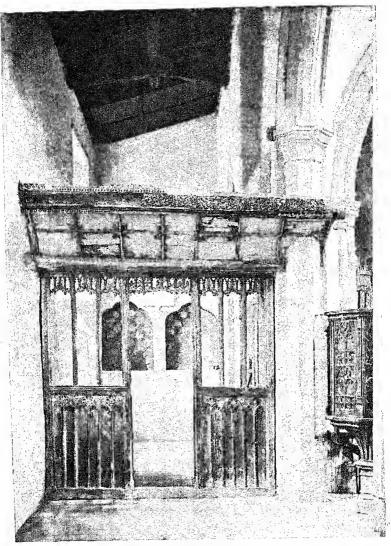
Fig. 38. Hanborough Church, Oxon. The Screen After Repair by Mr. William Weir in 1911
